Debris/Ice/TPS Assessment And Integrated Photographic Analysis For Shuttle Mission STS-49

July 1992

Gregory N. Katnik
NASA/Kennedy Space Center

OV-105 Endeavour (1st flight), ET-43 (LWT 36), BI-050 SRBs

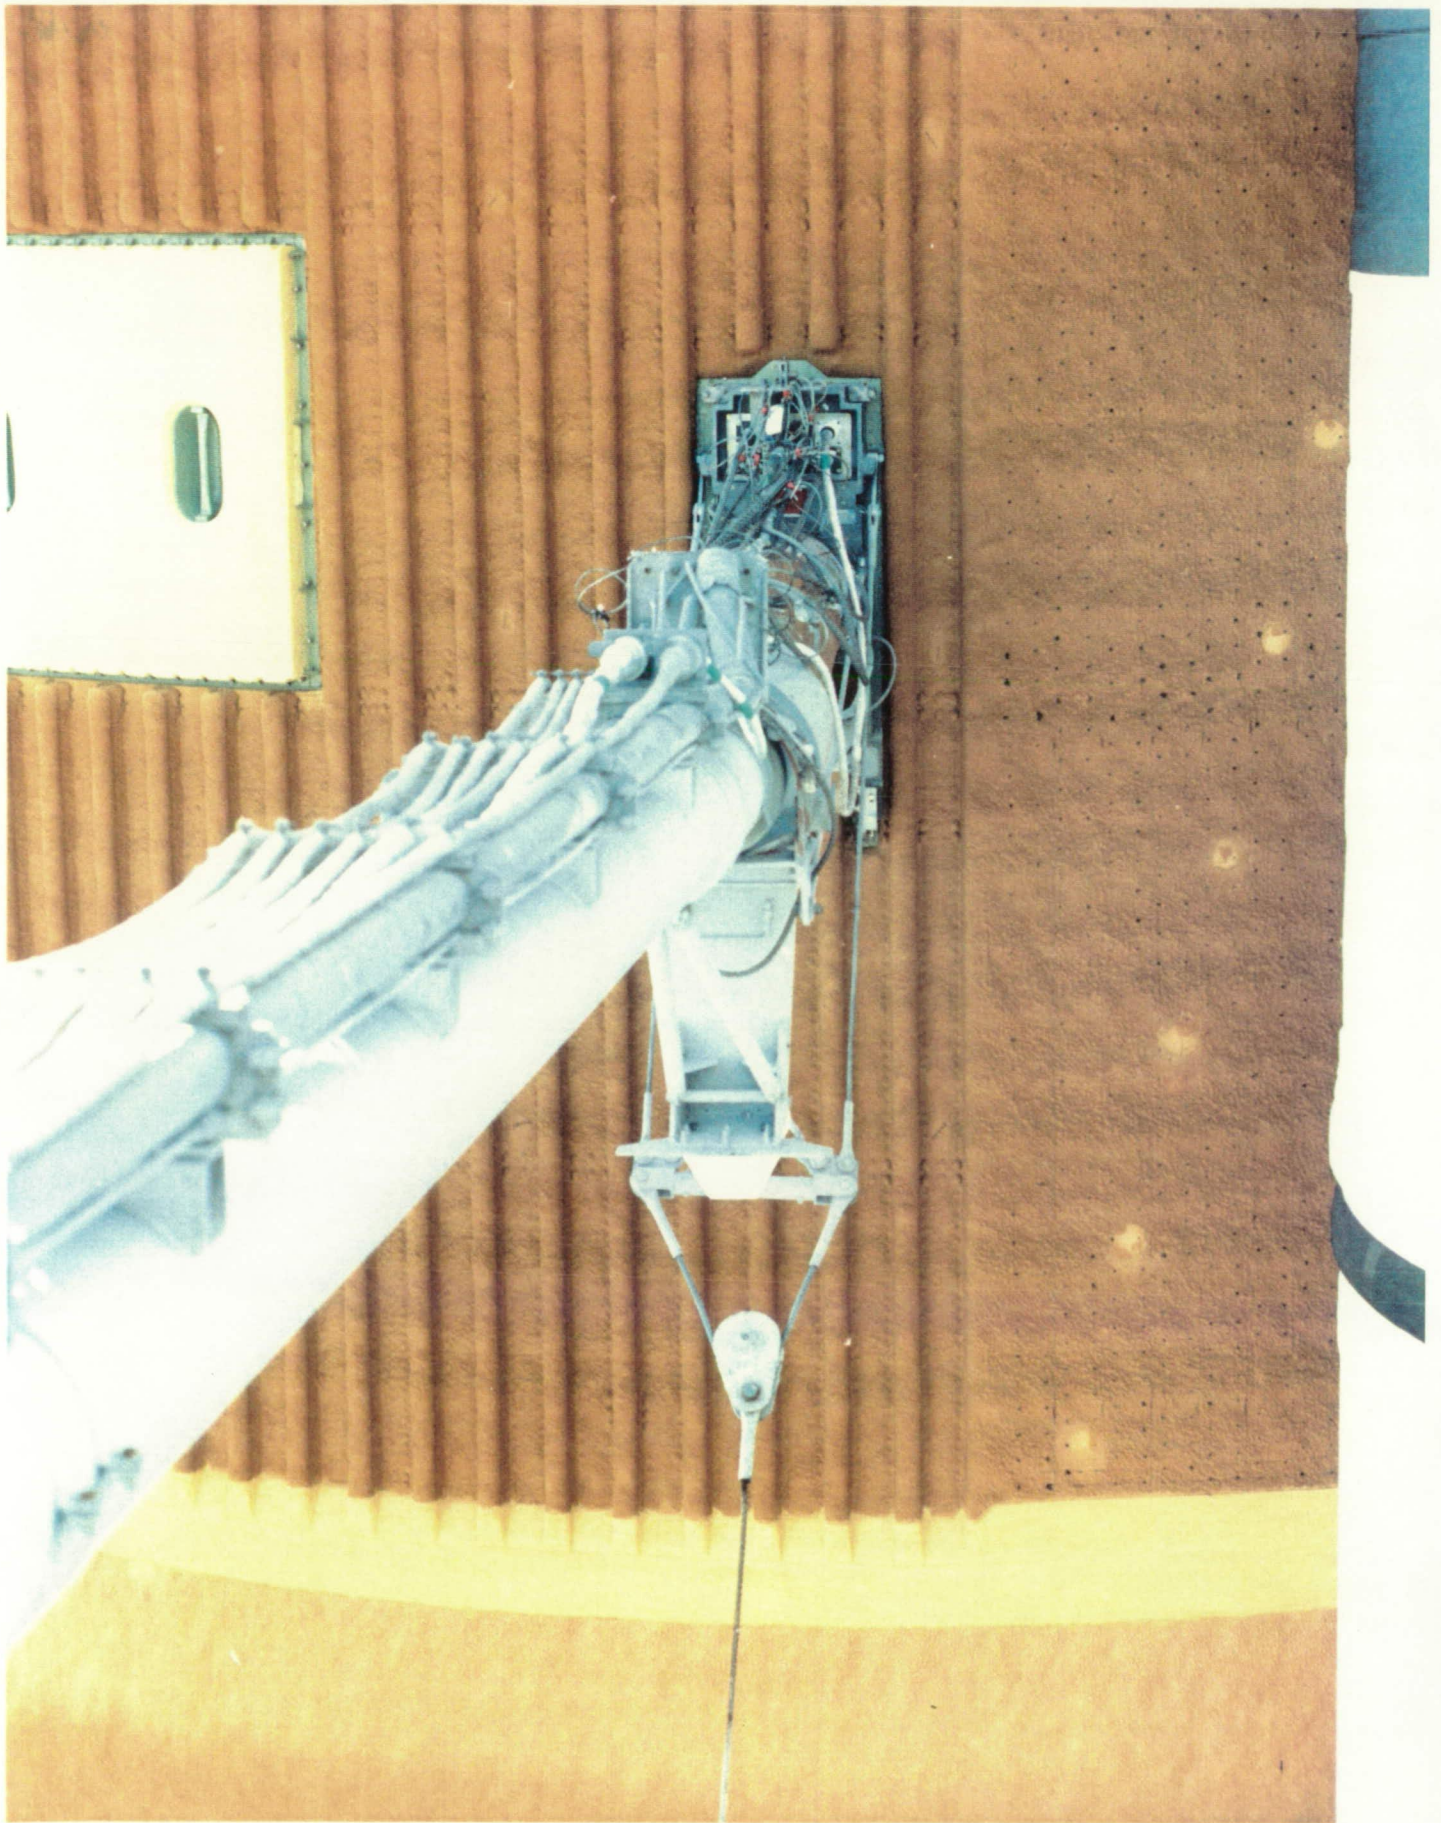
Intertank thrust panel/stringer TPS prior to cryogenic loading

Overall view of the intertank TPS prior to cryogenic loading. A thermal stress crack, which had formed in the first stringer valley adjacent to the thrust panel during the FRF cryogenic loading, had closed up and is not visible when the tank is at ambient temperature.

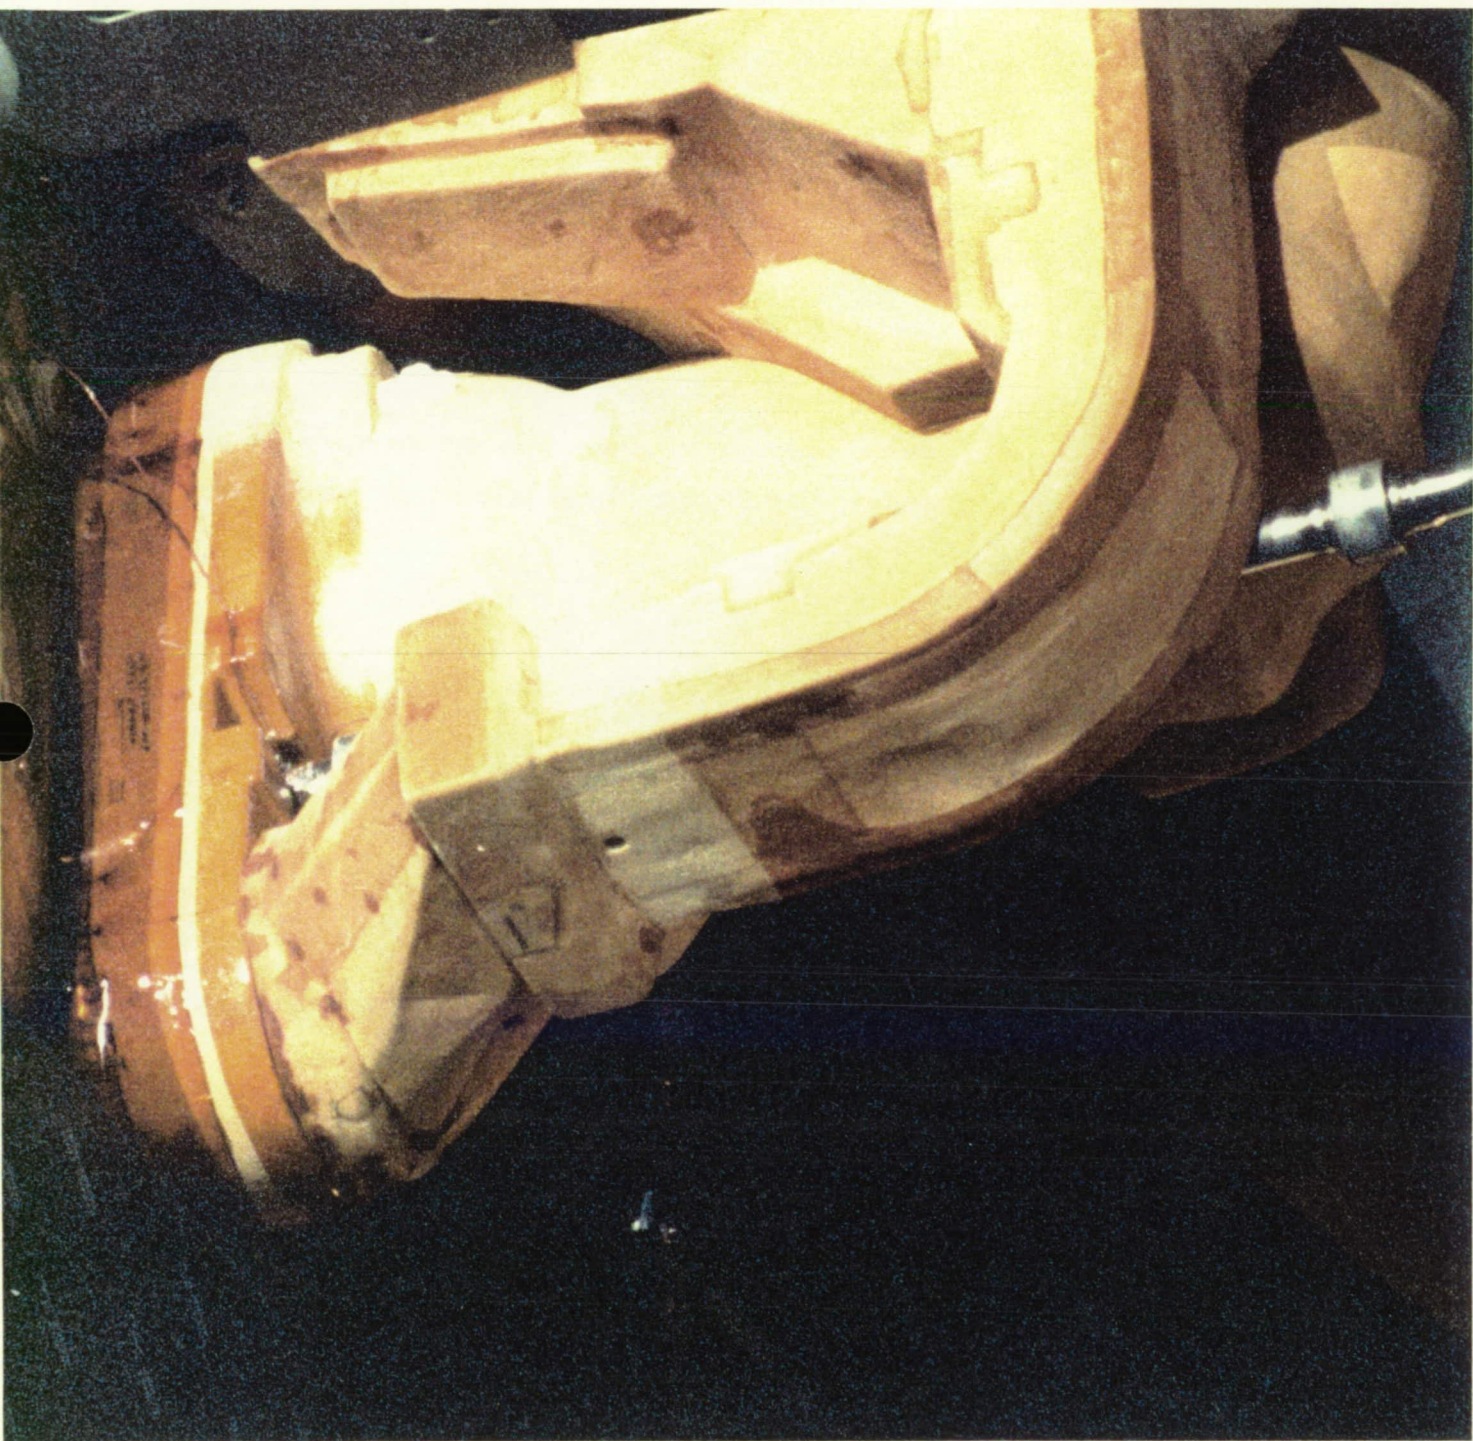
No anomalies were visible on the LO2 ET/ORB umbilical

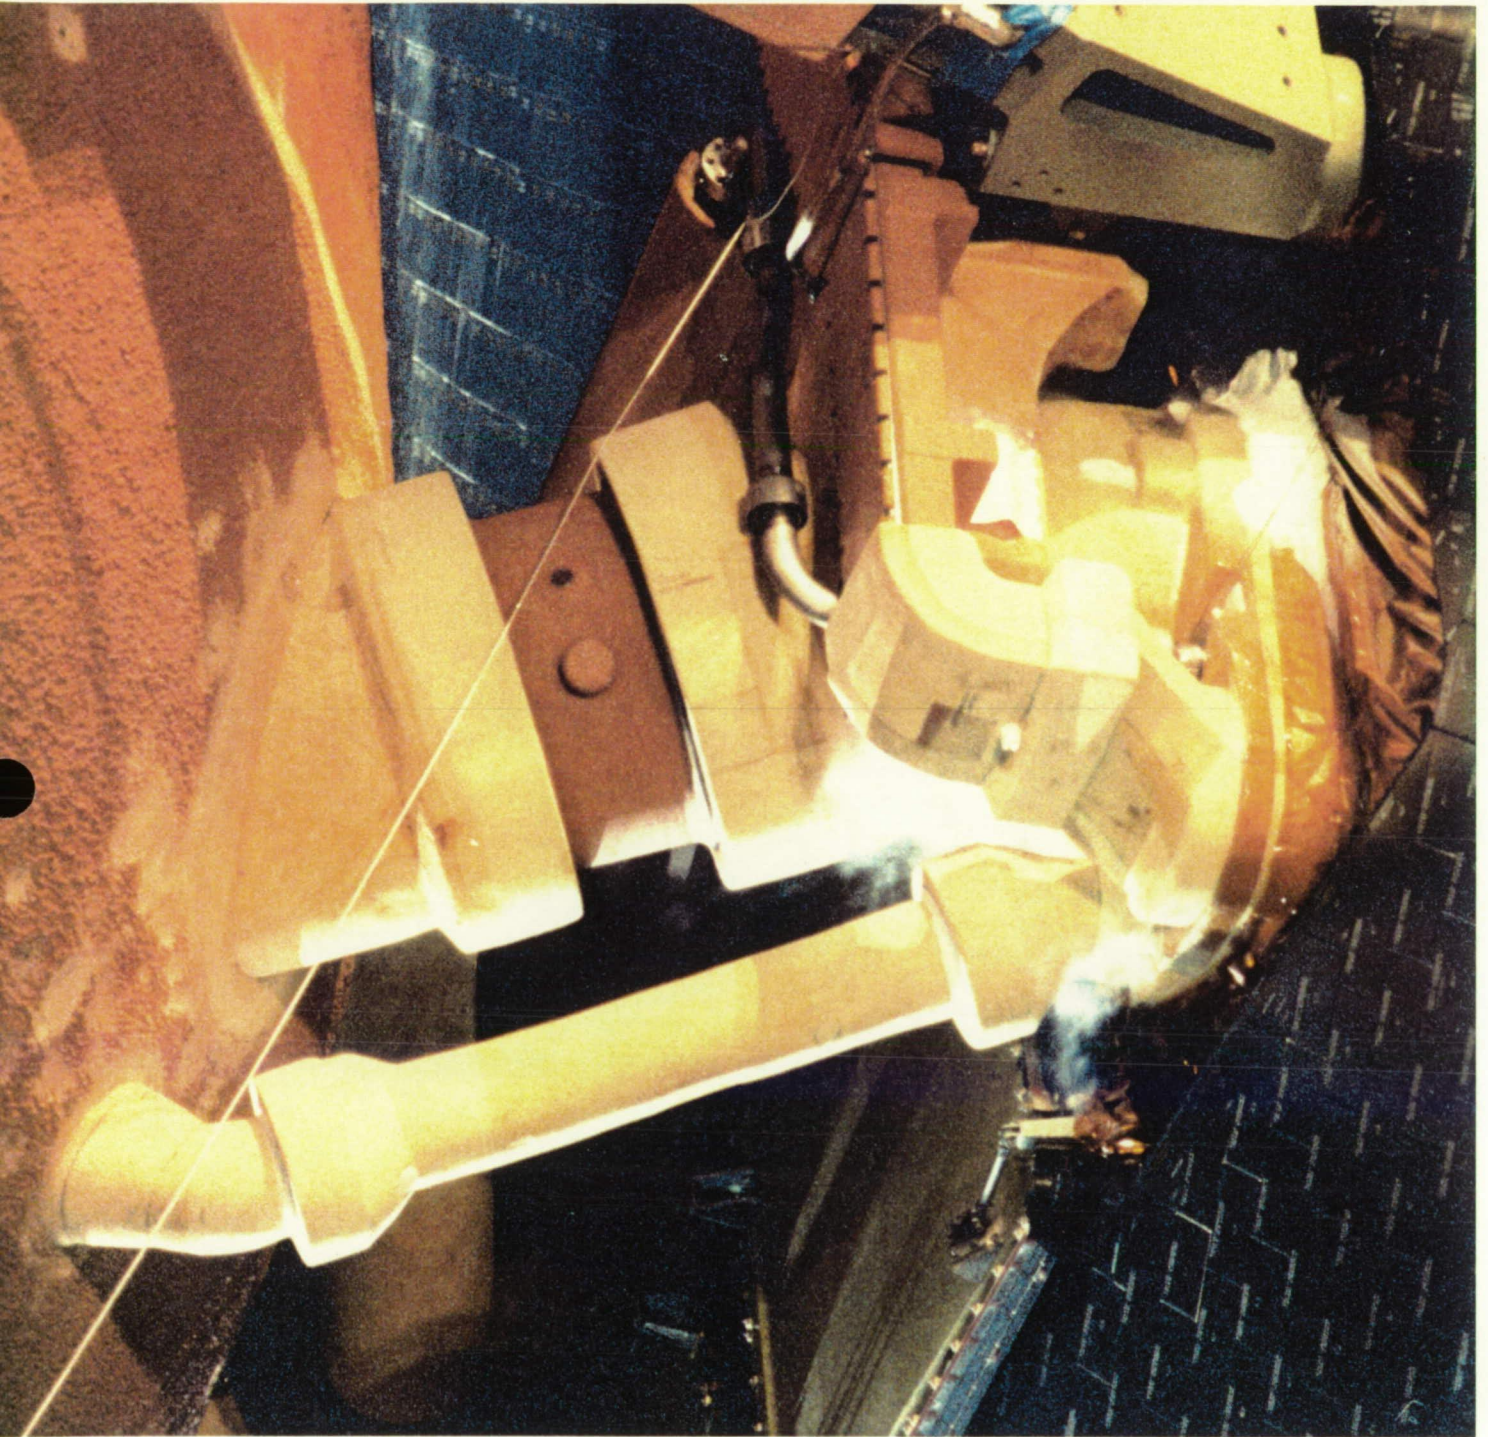
Ice/frost accumulations on the top and outboard sides of the LH2 ET/ORB were umbilical typical. There were no unusual vapors emanating from the umbilical nor any evidence of cryogenic drips.

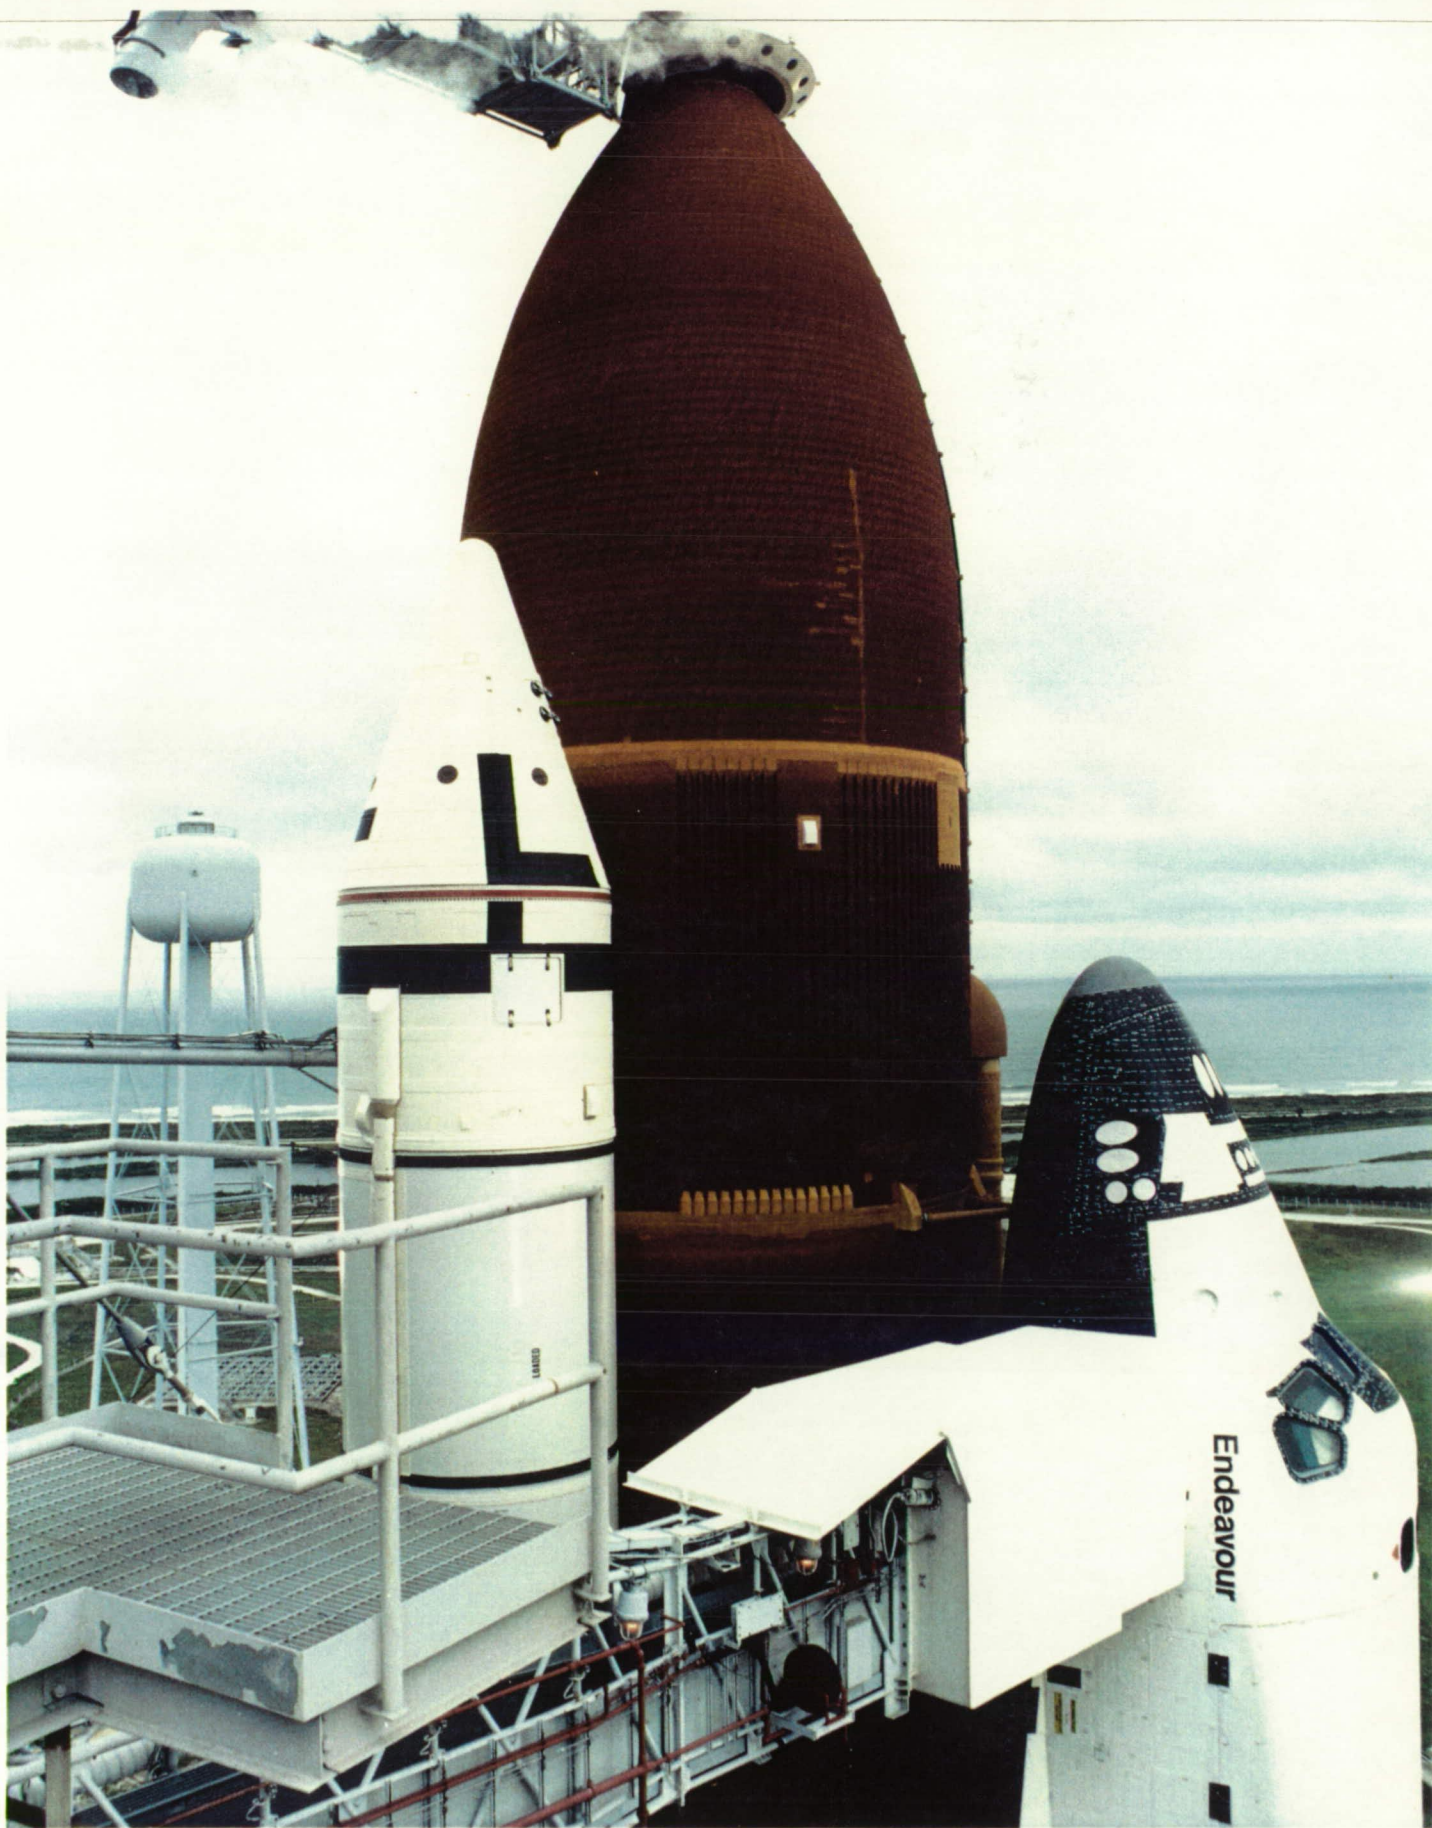
Light condensate, but no ice, frost, or TPS anomalies, were present on the acreage of the LO₂ tank ogive and barrel section

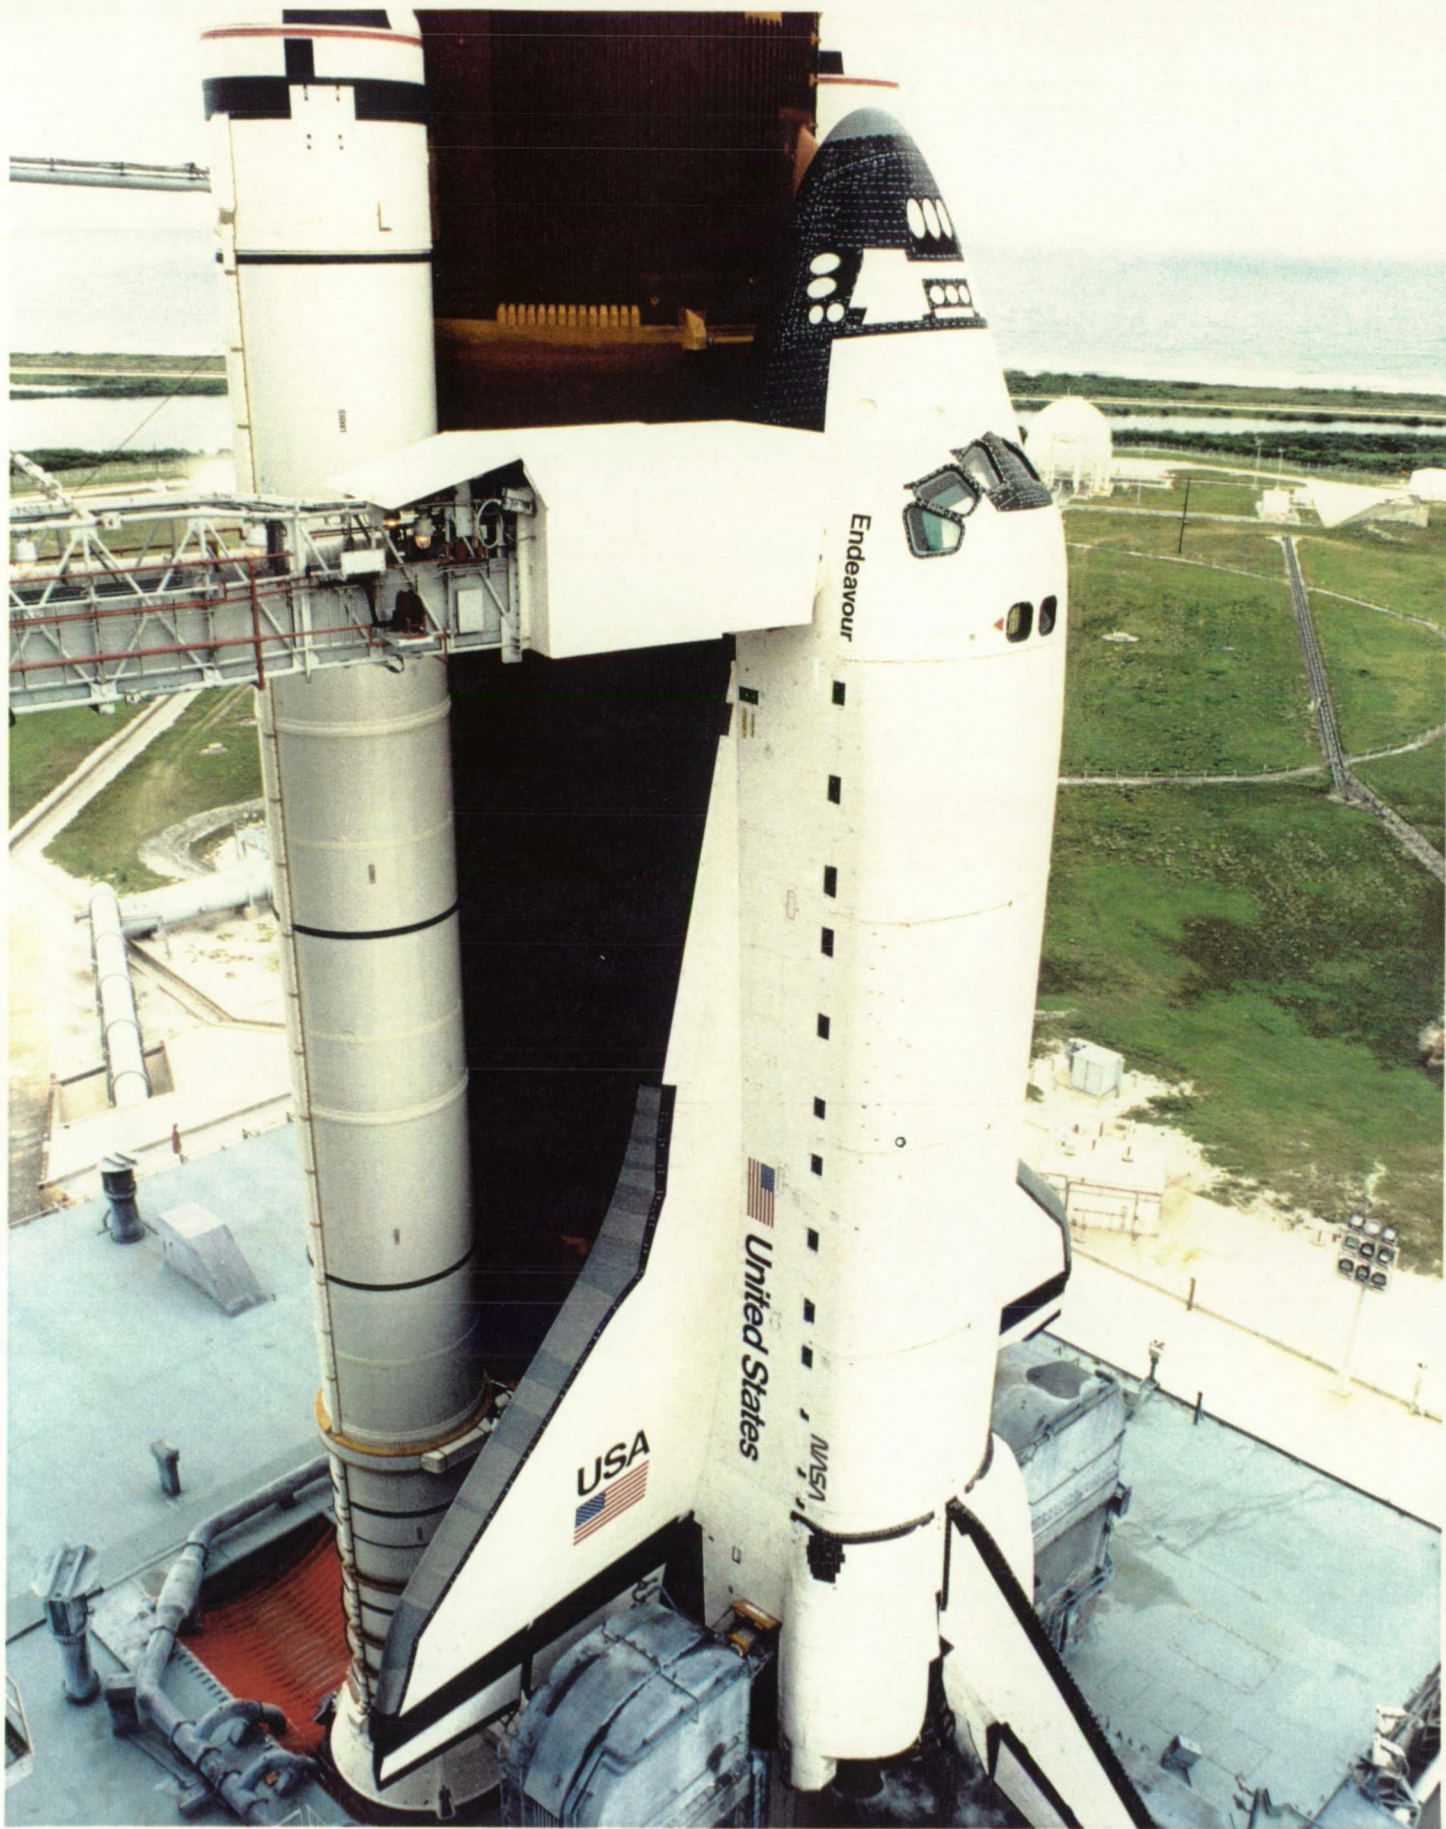
Light condensate, but no ice, frost, or TPS anomalies, were present on the LH2 tank acreage and aft dome. There were no SRB or Orbiter anomalies.

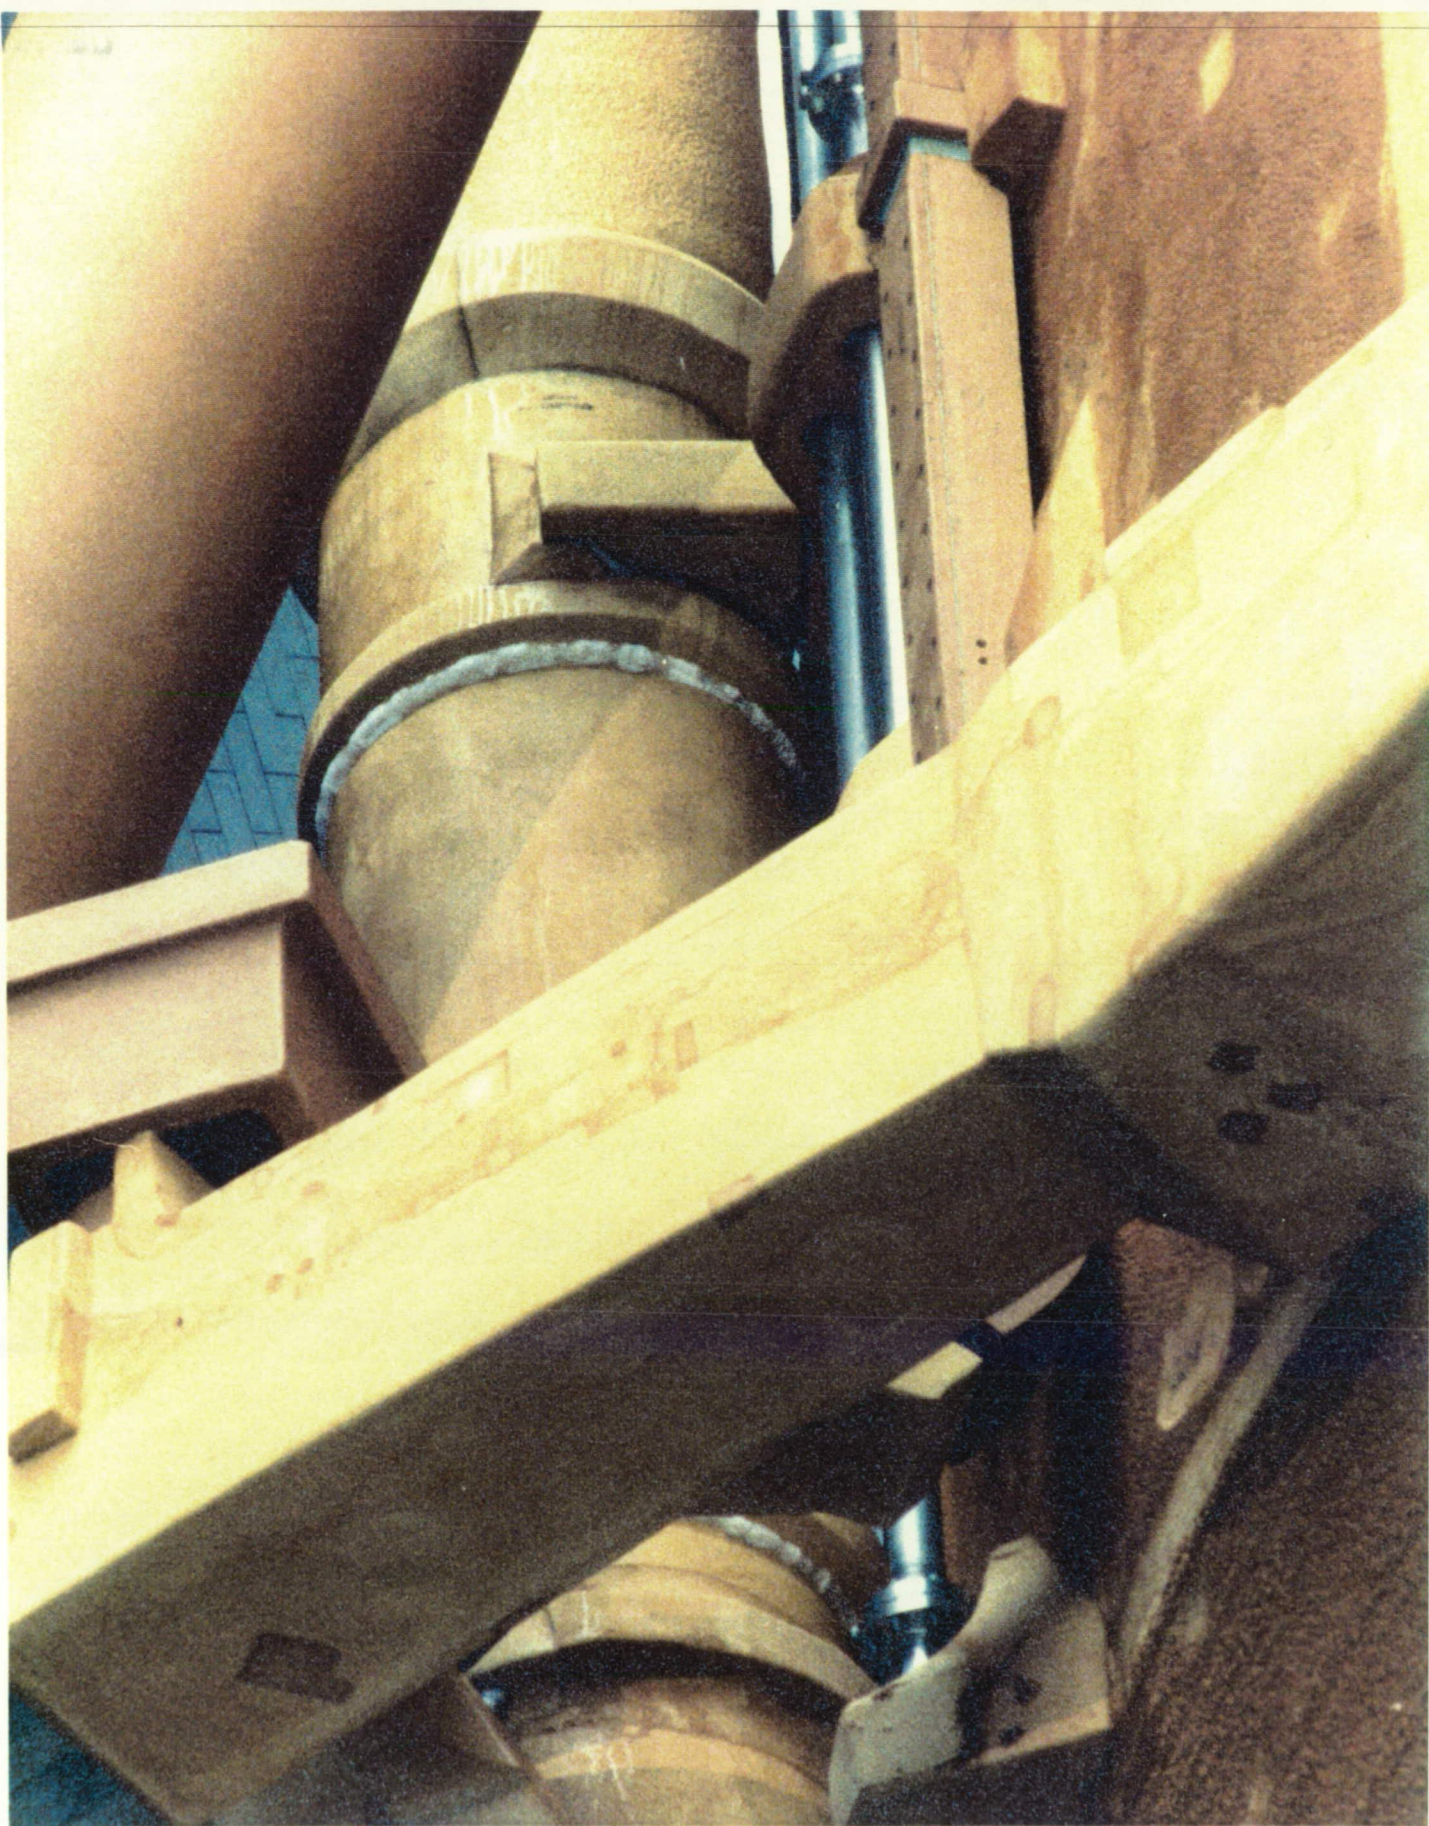
Ice/frost formations in the L02 feedline support brackets and lower bellows were acceptable per the NSTS-08303 criteria.

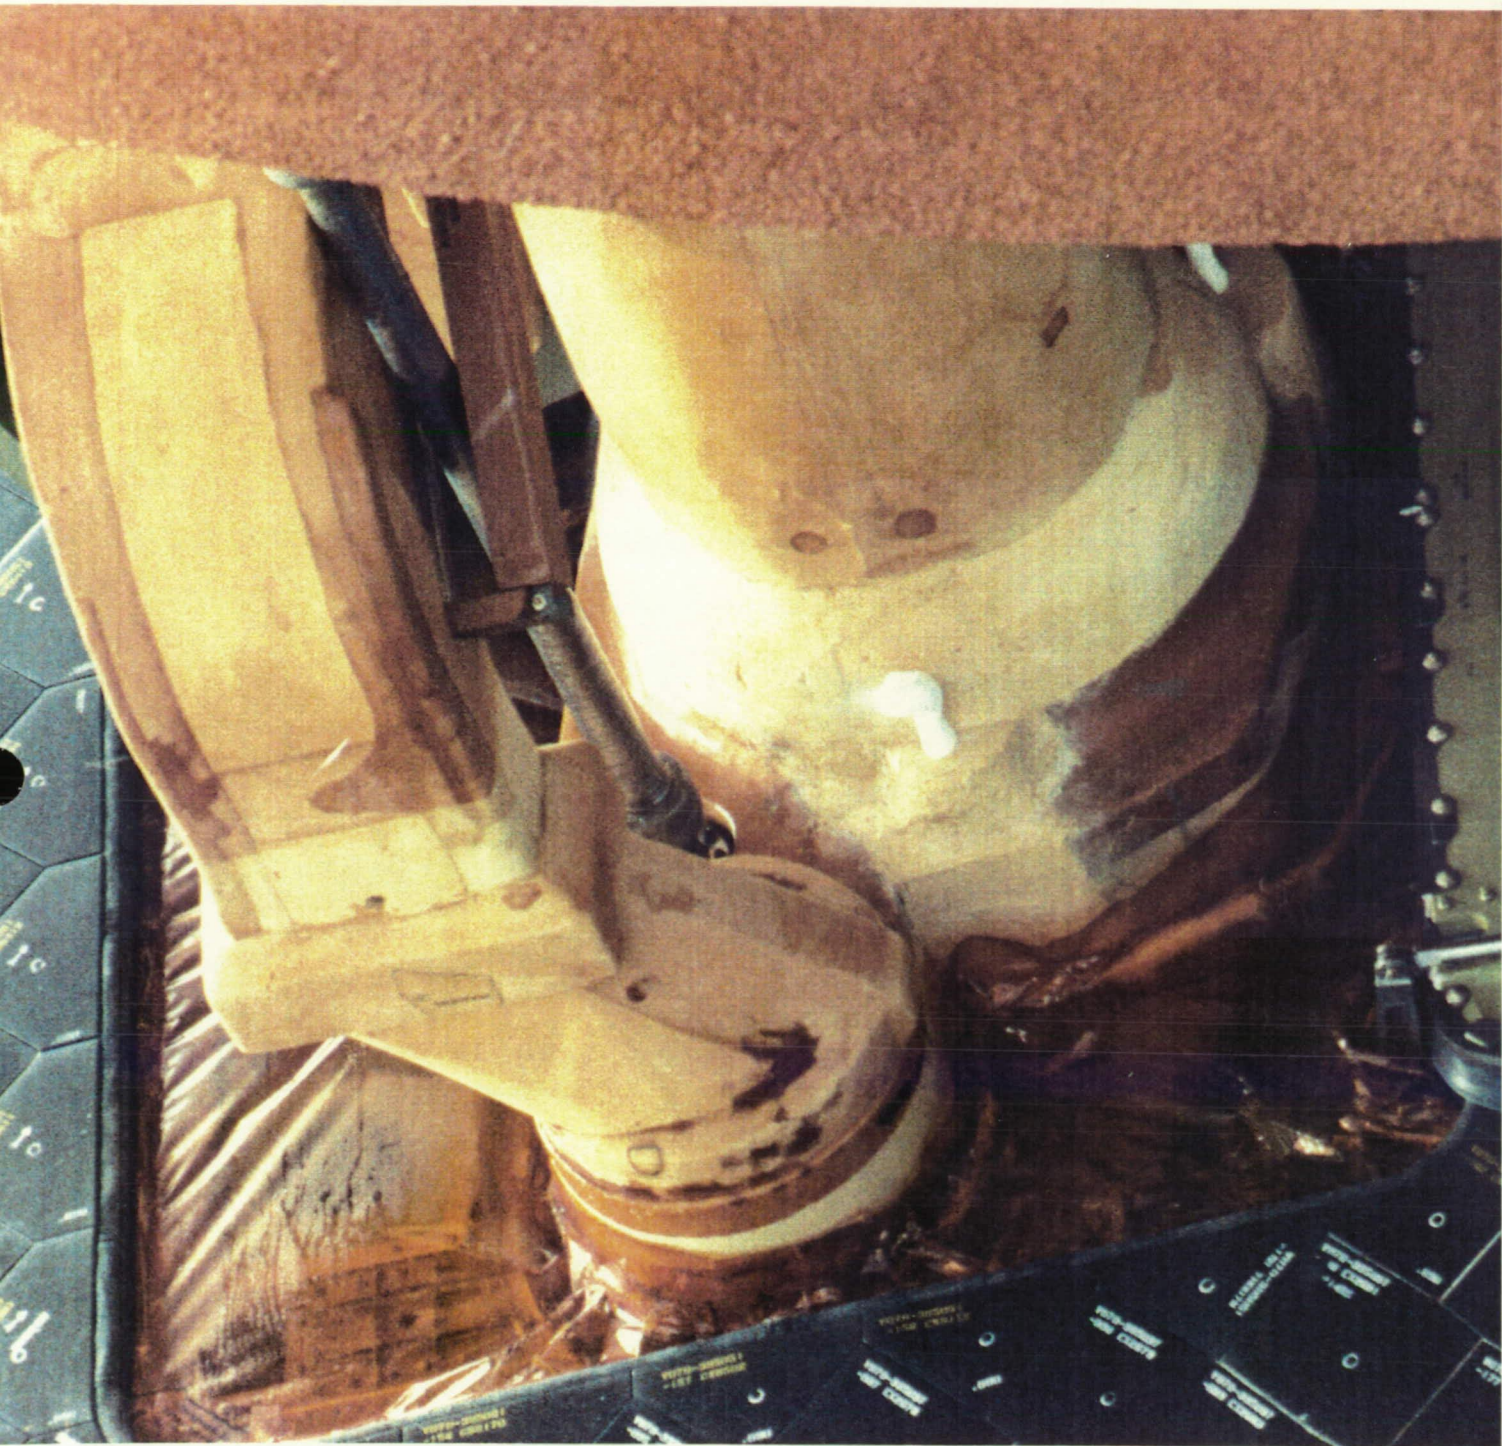
There were no TPS anomalies on the LO2 ET/ORB umbilical. Ice and frost formations on the purge vents were typical. Normal venting of nitrogen purge gas had occurred during tanking, stable replenish, and launch.

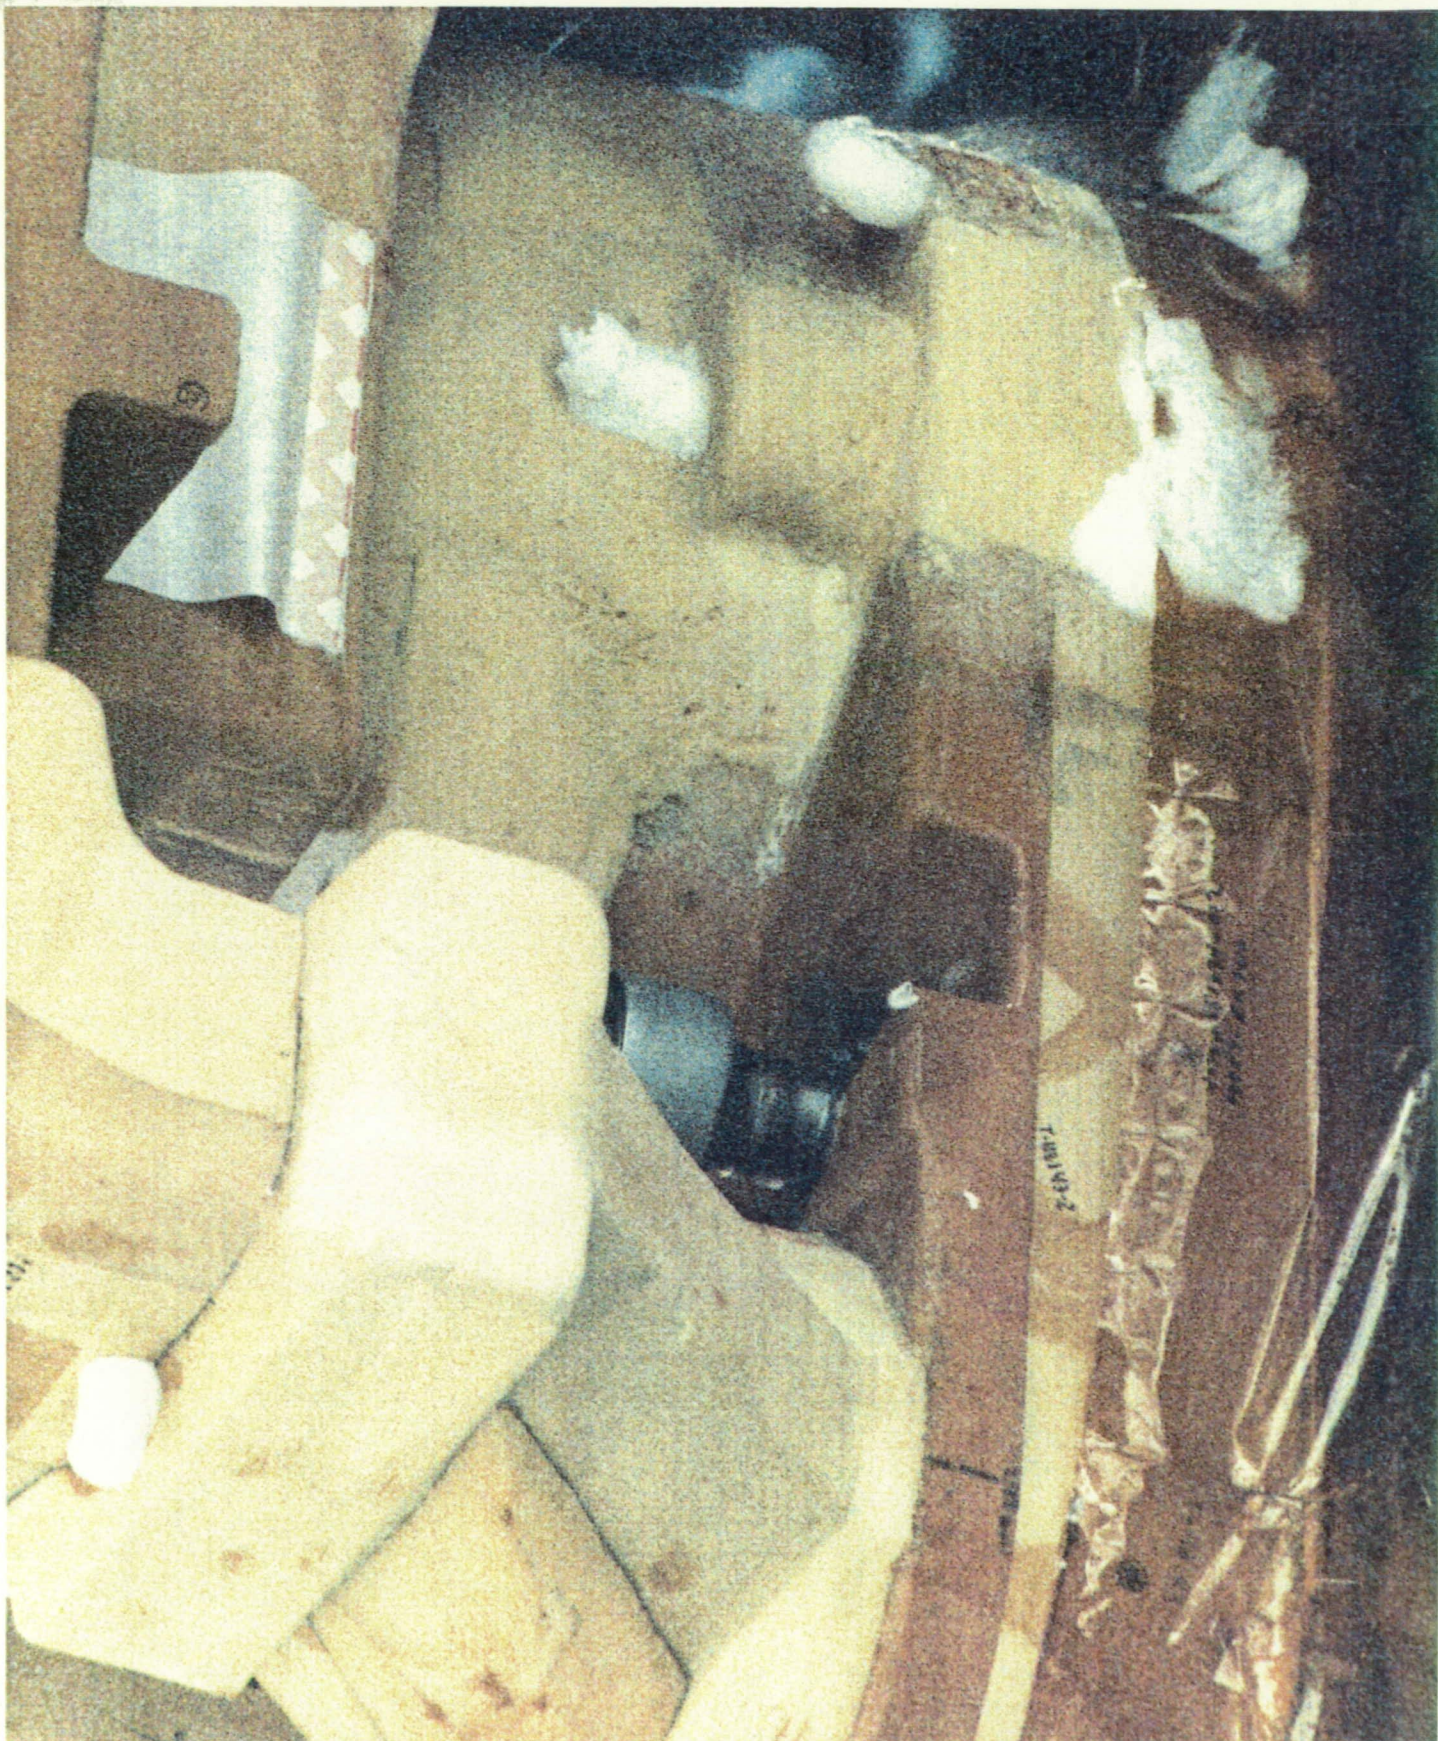
View of the LH2 ET/ORB umbilical. There were no unusual vapors emanating from the umbilical nor any evidence of cryogenic drips. Ice/frost accumulations on the umbilical purge vents and on the top/outboard sides of the umbilical were typical.

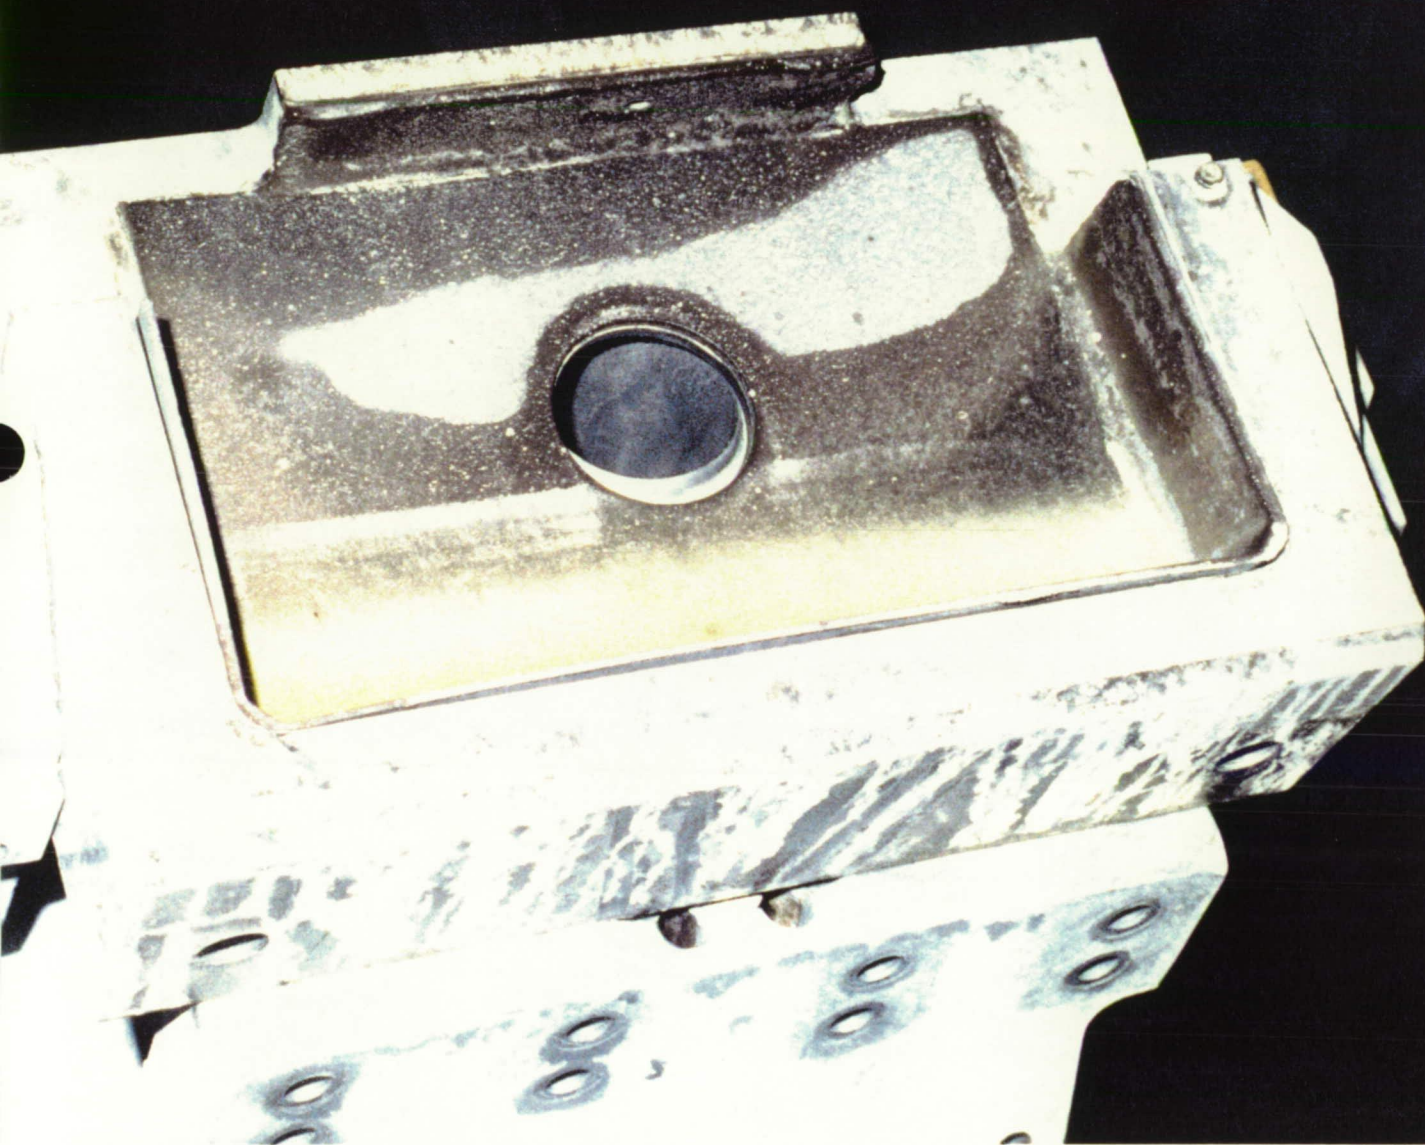
Plume erosion of the south SRB holddown posts was typical. EPON shim material was intact, but debonded along the sidewalls.
